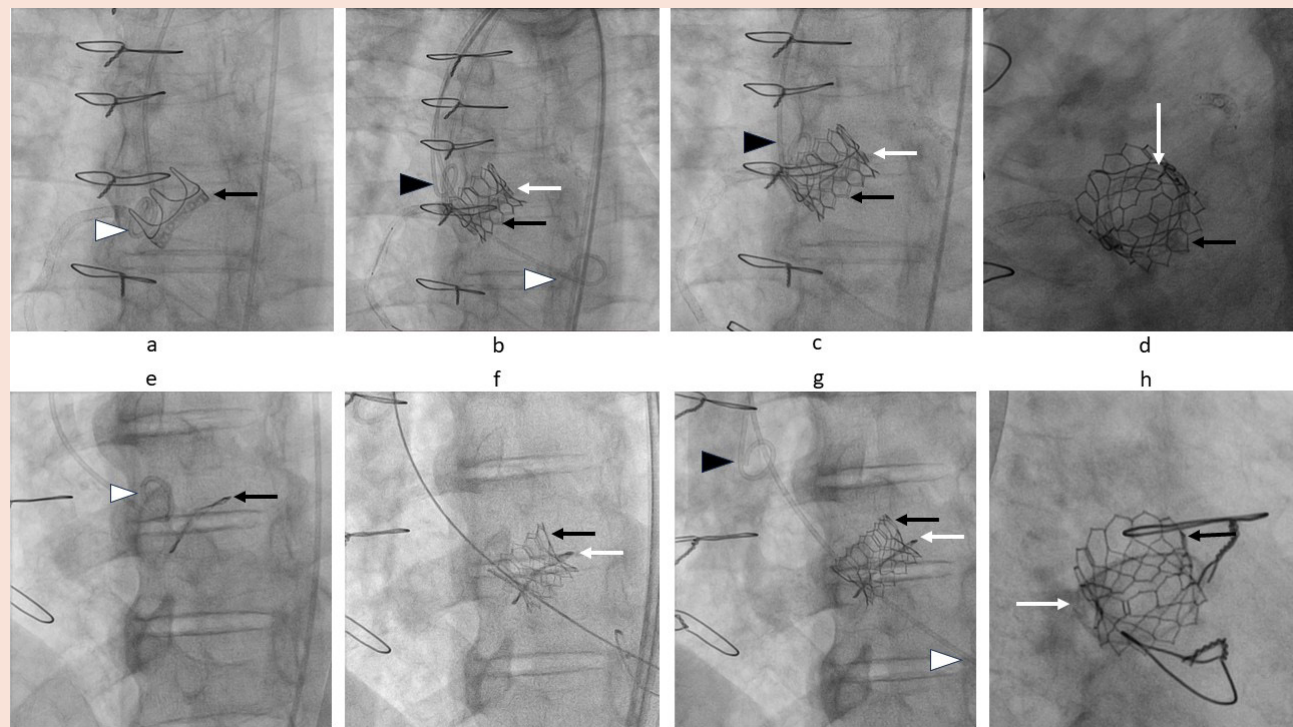
(A) Fluoroscopic image of the 21 mm Perimount surgical valve (arrow) in the aortic position. The arrowhead denotes the pigtail catheter in the aortic root. (B) Fluoroscopic image of the 23 mm Sapien 3 THV (black arrow) within the 21-mm Perimount surgical valve. The white arrow denotes the “waist” where the Sapien 3 THV is constrained by the sewing ring of the Perimount surgical valve. The black and white arrowheads denote the pigtail catheters in the aortic root and LV, respectively. (C) Fluoroscopic image of the 23-mm Sapien 3 THV (black arrow) within the 21-mm Perimount surgical valve. The white arrow shows that the Sapien 3 THV is now well expanded within the Perimount surgical valve. The black arrowhead denotes the pigtail catheters in the aortic root. Successful BVF was indicated by a sudden visual release of the “waist” of the THV and a rapid drop in the balloon inflation device pressure. (D) Fluoroscopic image of the 23-mm Sapien 3 THV (black arrow) within the 21-mm Perimount surgical valve. The white arrow denotes the fracture of the sewing ring of the Perimount surgical valve. (E) Fluoroscopic image showing the sewing ring (arrow) of the Mitroflow surgical valve (the rest of the valve is not visible). The arrowhead denotes the pigtail catheter in the aortic root. (F) Fluoroscopic image of the 20 mm Sapien 3 THV (black arrow) within the 19-mm Mitroflow sewing ring. The white arrow denotes the “waist” where the Sapien 3 THV is constrained by the sewing ring of the Mitroflow surgical valve. (G) Fluoroscopic image of the 20-mm Sapien 3 THV (black arrow) within the 19 mm Mitroflow surgical valve. The white arrow shows that the Sapien 3 THV is now well expanded within the Mitroflow surgical valve. The black and white arrowheads denote the pigtail catheters in the aortic root and LV, respectively. Successful BVF was indicated by a sudden visual release of the “waist” of the THV and a rapid drop in the balloon inflation device pressure. (H) Fluoroscopic image of the 20-mm Sapien 3 THV (black arrow) within the 21-mm Perimount surgical valve. The white arrow denotes the fracture of the sewing ring of the Mitroflow surgical valve. BVF: bioprosthetic valve fracture; LV: left ventricle; THV: transcatheter heart valve
