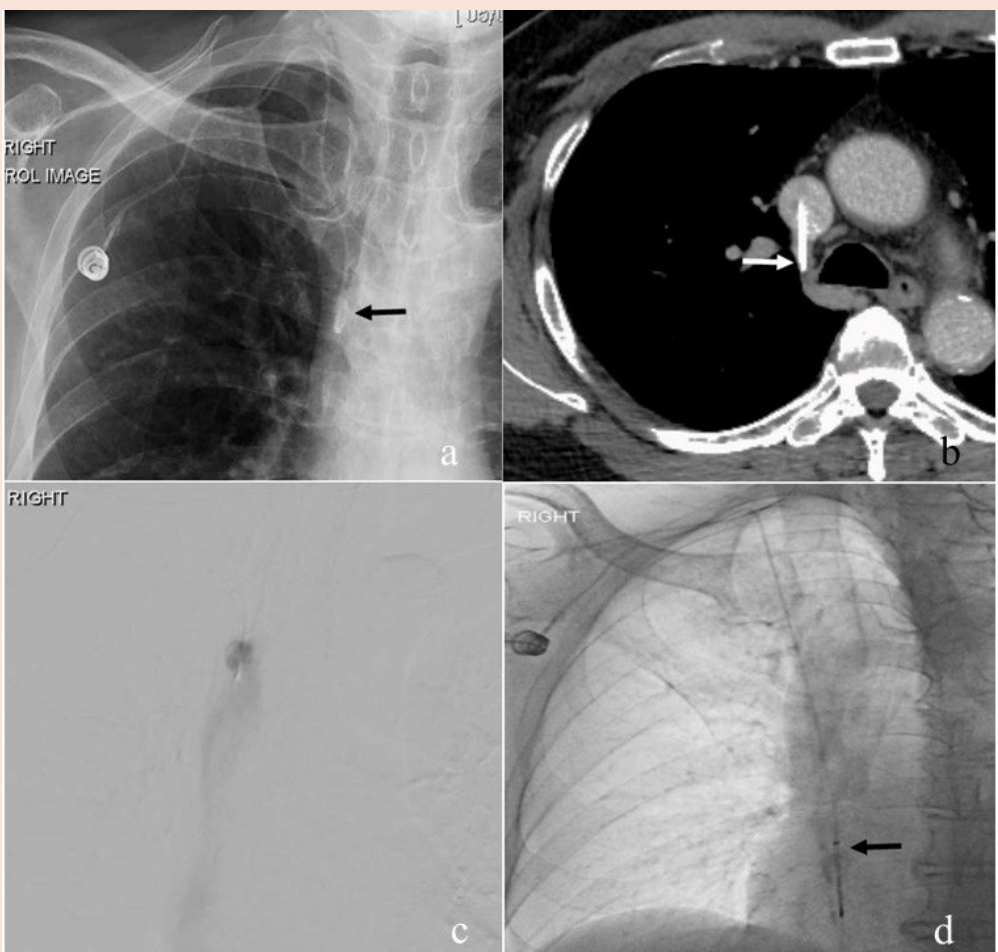
(A) The chest radiograph of a Braintree Babyport shows the distal end of the catheter looping cranially and making a U-turn (arrow). (B) Contrast-enhanced computed tomography (CT) shows the catheter tip has malpositioned into the azygos vein (arrow). (C) Linogram demonstrated a patent catheter within the azygos vein, which was partially opacified. (D) The catheter tip was successfully repositioned back into the cavoatrial junction with an endovascular snare (arrow).
